Mobile Intel[®] Pentium[®] II Processor Specification Update

Release Date: October 2001

Order Number: 243887-034

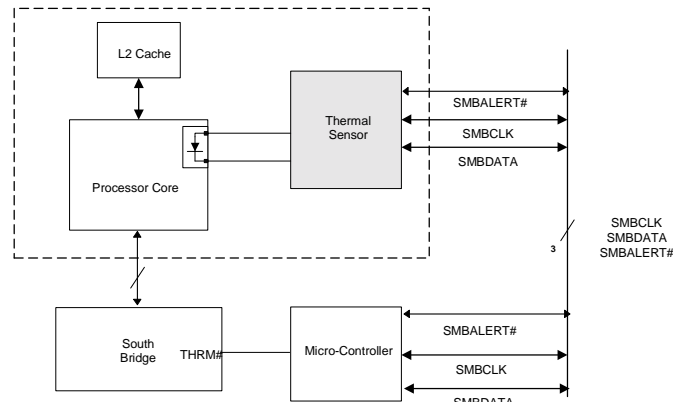
Figure 1. An Example of Microcontroller Driven Thermal Management

Problem: The Mobile Pentium II processor and the Pentium II Processor Mobile Module have a thermal sensor that monitors the processor core's temperature. Please note that desktop systems could have a similar thermal device. The thermal sensor asserts SMBALERT# if the processor temperature exceeds the temperature limits set in the Alarm Threshold Registers (T_{HIGH} , T_{LOW}). It also sets the corresponding Status Register bits to identify the cause of the interrupt. Figure 1 gives one example of the how the SMBALERT# signal could be used in a system.

Under the conditions described below, the thermal sensor incorrectly generates the SMBALERT# interrupt. All of the following conditions must be met to trigger a false interrupt:
